Greenfield

Historic District Design Review Guidelines 2011

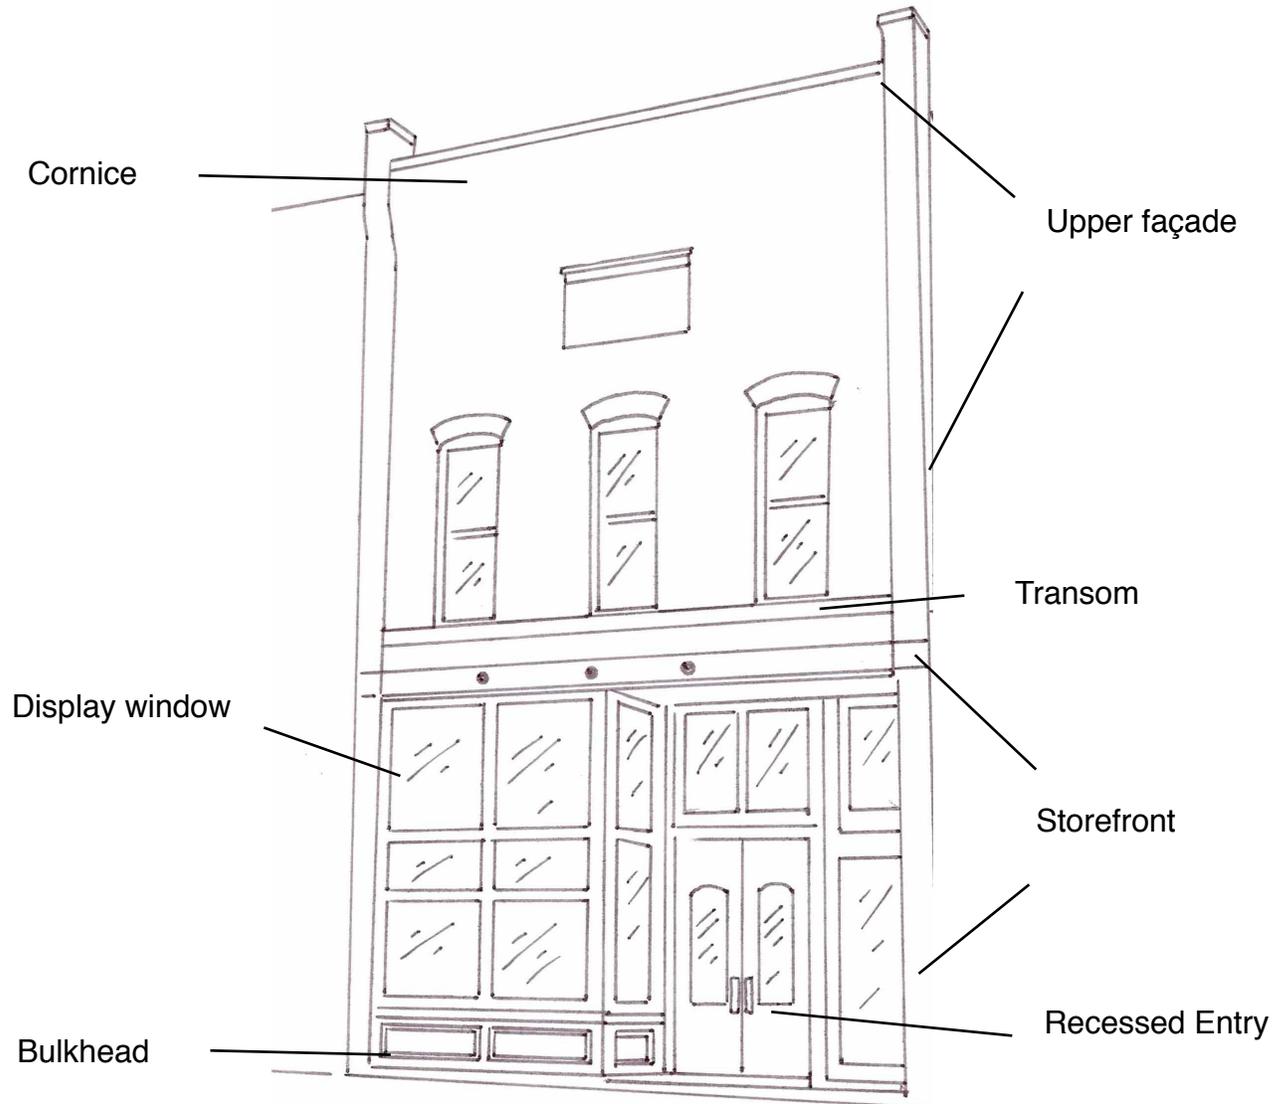
The basic traditional commercial façade consists of three parts: the storefront with an entrance and large display windows, an upper masonry façade and a decorative cornice. The basic storefront design includes large windows with thin framing members, a storefront cornice, transom, bulkheads and often a recessed entrance.

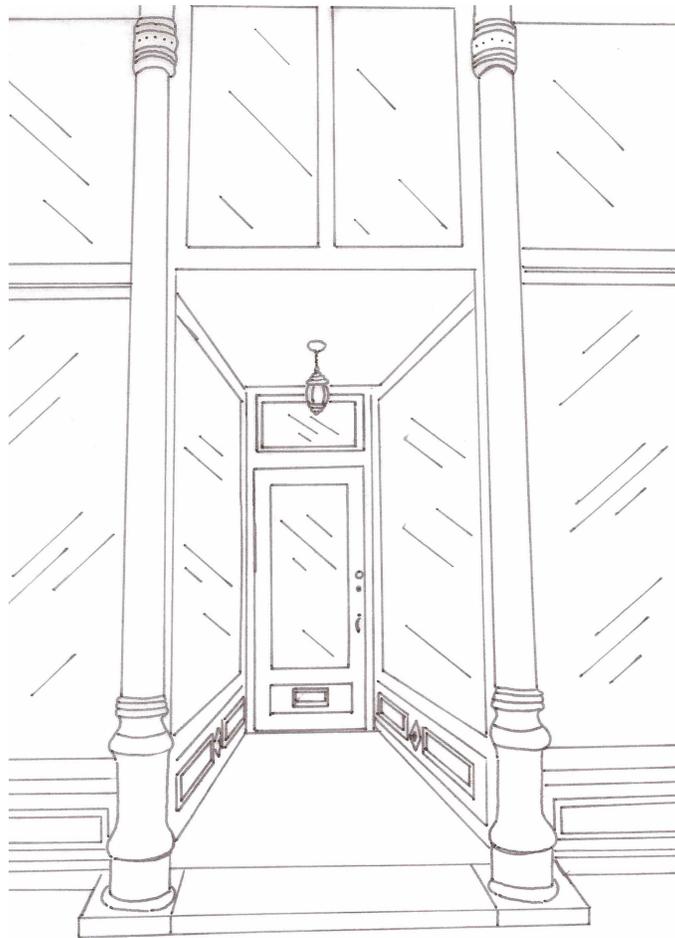
Traditional recessed entryway

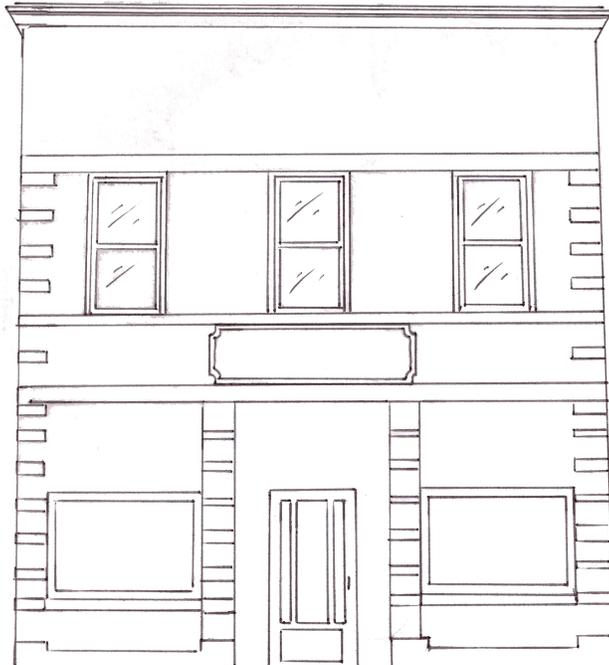
Reducing the size of storefront windows is inappropriate

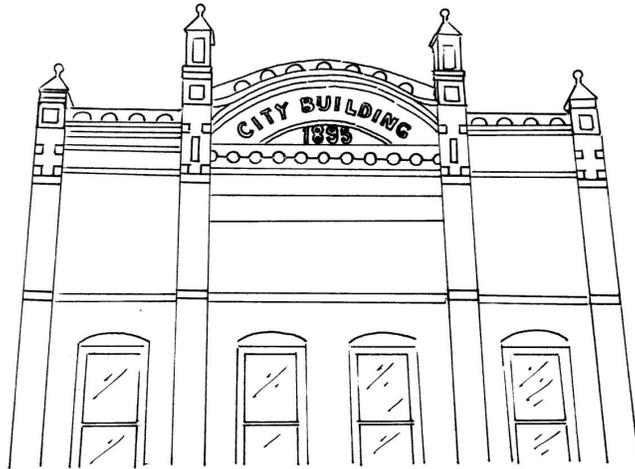
The Old City Building displays an elaborate cornice

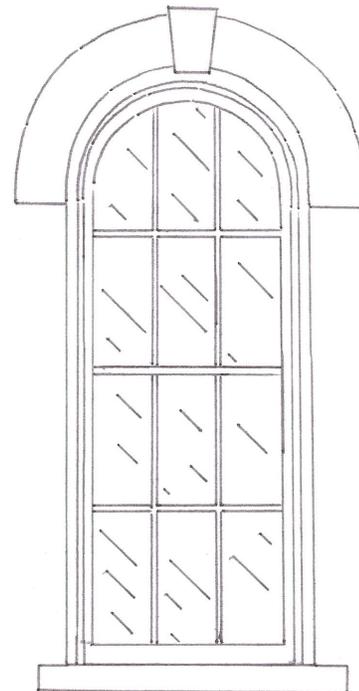
The shape and design of this original window help define the building’s character

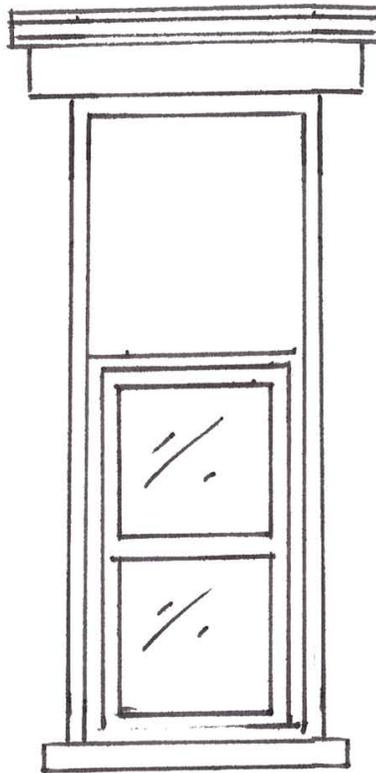
An inappropriate window alteration

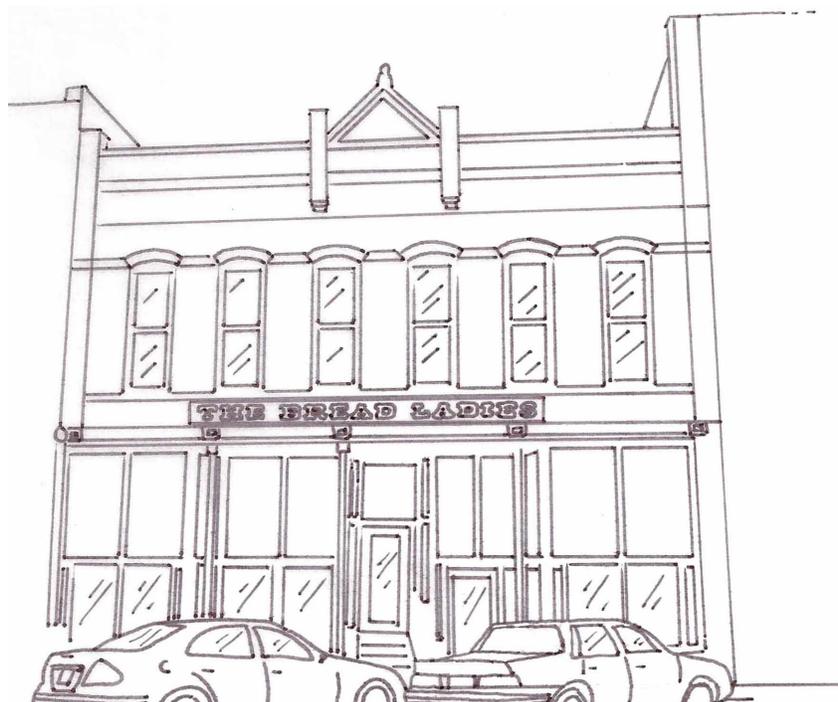
Example of a wall sign

1. Wall signs: any sign affixed in such a way that its exposed face and sign area is parallel to the plane of the building to which it is attached. Wall signs should be placed where they best complement the building, for example, on blank expanses of wall or building areas clearly designed as potential sign locations, covered transoms, or broad plain fascias in the cornices. Such areas vary depending on the building's architectural style and/or date of construction.
2. Projecting signs: any sign affixed in such a way that its exposed face and sign area is perpendicular to the plane of the building to which it is attached. Projecting signs should be placed where they best complement the building.
3. Window signs: signs painted on, attached to, or suspended behind any window or door that serves as an identification of a business.

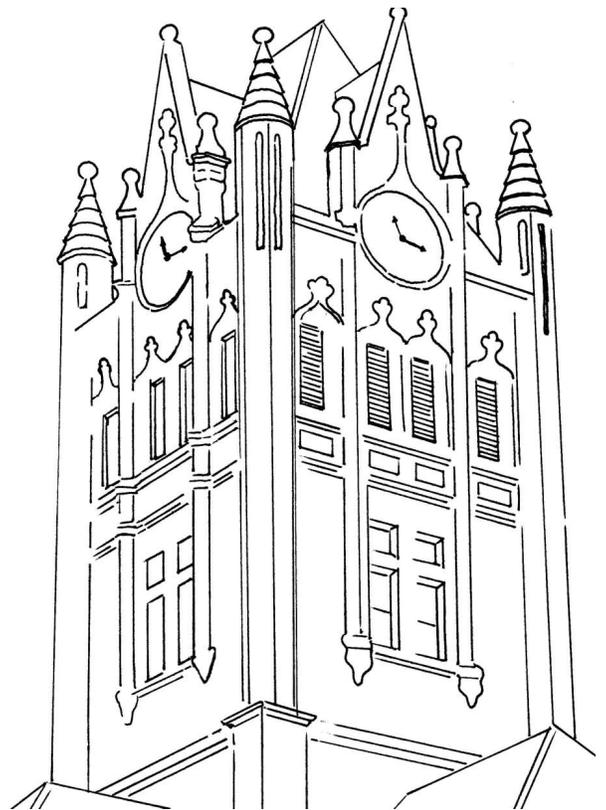
The courthouse is a fine example of stone masonry construction

Stone masonry has been utilized as a building material in Greenfield both on its own, and in combination with other materials. Examples of the former are Masonic Hall and the Courthouse. Indiana limestone is a prevalent variety. Surfaces vary from smooth to rustic. Visible limestone masonry units are in excellent condition. This attests as much to the quality of the stone supplied as to the skill of the designers and artisans who set it.
